# Arnest Inspections, Property Report

Property of inspection: 1015 Sample, San Francisco CA

Date of inspection: Tuesday, November 26, 2024

## THE BUILDING INSPECTION

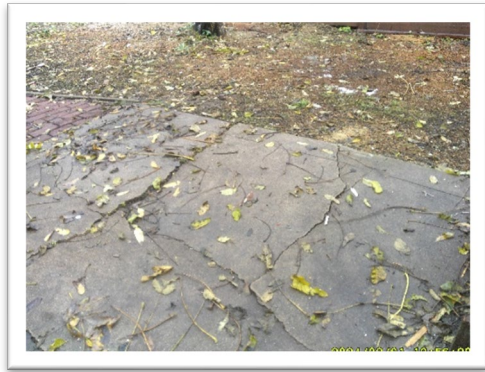
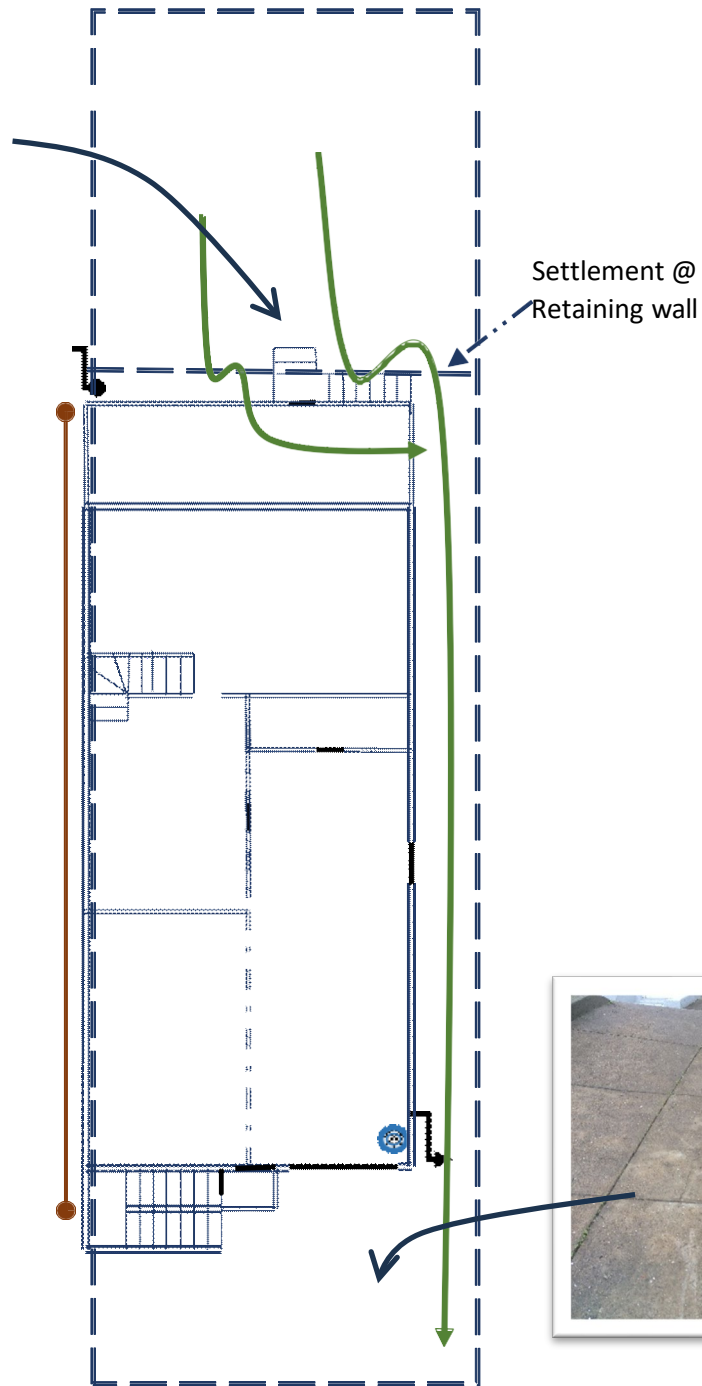
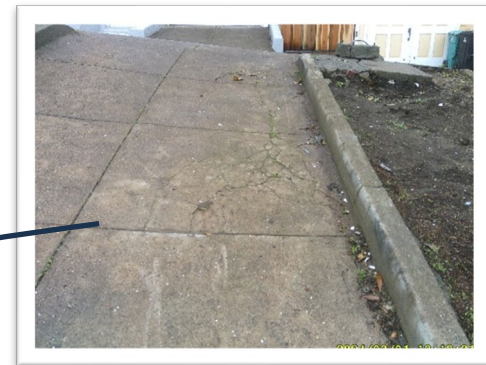
### A - GENERAL LOT (page 1):

- 1 **Slope:** Slow from the rear fence to the deck then steps down. Steeper down to the front sidewalk then steep to the street.
- 2 **Yard Pathways:** Cracked with settlement noted at the patio. Uneven bricks at the yard.
- 3 **Fencing/Yard:** New and functional.
- 4 **Retaining walls > 2'?** The mid-wall between yard and steps has settled. Refer to an engineer for opinion.
- 5 **Walls on Lot Lines?** The left side is set close to the neighbor's wall. Drainage is an issue. See the WDO report.

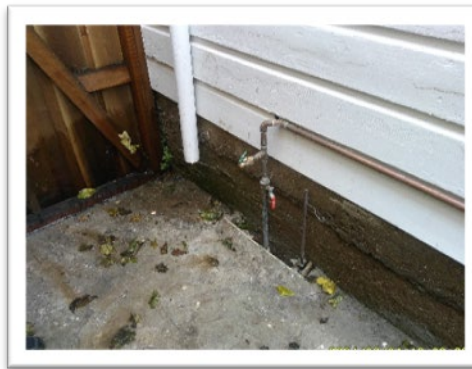
- 6 **Area drains visible?** There is an area drain at the garage door.
- 7 **Visible drain sump?** None.
- 8 **Drainage termination:** Main left side roof drainage is into the sewer system from a downspout at the left rear.  
The right-side drainage is into the ground at the right front (should be into the sewer/storm system to meet SF standard for greater than 200 square feet).

- 9 **Drainage problems?** At the right-side basement door, water enters and has caused wood decay (poor repair evident)  
At the left front side, water enters at the foundation and has caused decay.  
See WDO report.

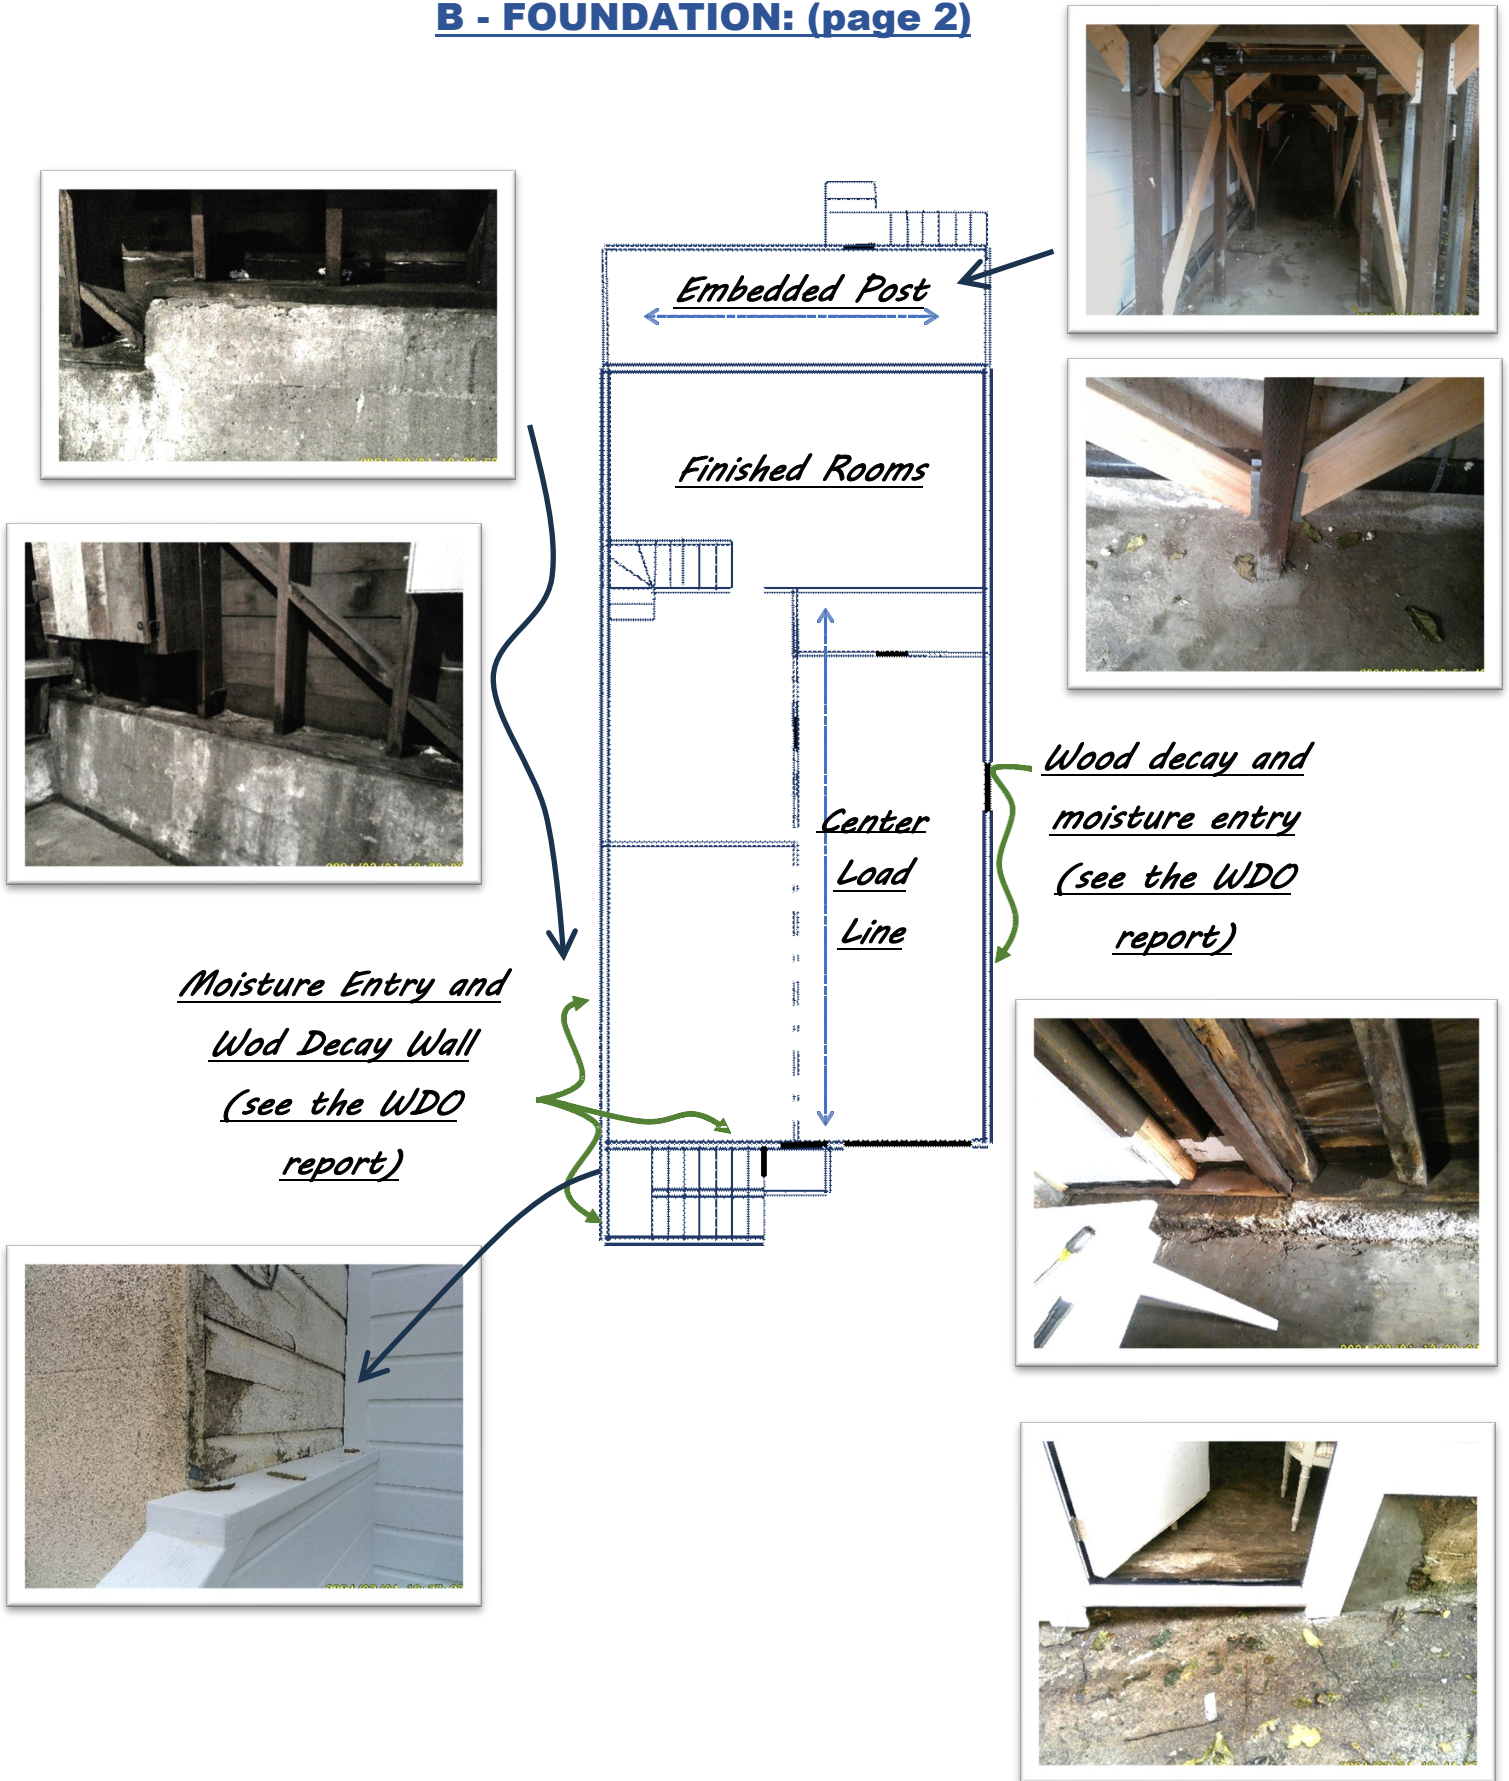
### B - FOUNDATION: (page 2)

- 13 **Construction type:** Wood platform joist over cripple wall frame.  
Posts set into the ground at the part that extends beyond the rear basement wall.
- 14 **Foundation type:** Concrete.
- 15 **Soil coverings:** Thin concrete (typical of older SF homes).
- 16 **Soil retention:** Foundations also act as retaining walls.
- 17 **Alterations?** Rear extension supports are set into the ground.
- 18 **Limitations?** Framing at the rear basement room is not visible.

- 19 **Anchor bolts?** I did not find anchor bolts at the foundation sill plates. Upgrade recommended.
- 20 **Post connectors?** Post to beam load points should have additional re
- 21 **Shear walls?** No shearwall plywood was visible.
- 22 **Upgrades?** None.

- 23 **Foundation cracks?** Possibly at inaccessible areas. Areas that were not visible or were not accessed at this inspection time (closed walls, locked rooms, areas of storage).  
Patchwork noted at the right-side basement entry.
- 24 **Floor cracks?** No severe cracking was noted at the visible and accessible basement floor.
- 25 **Spalling?** Yes. Surface spalling is evident at parts of the foundation. Spalling occurs when impurities and moisture in the aggregate cause the surface to split off.
- 26 **Efflorescence?** Some white mineral deposits on the surface of concrete from moisture saturation.
- 27 **Settlement?** Upper floors show outward signs of some settlement (not level or out of plumb).
- 28 **Engineer recommended?** Grade level issues. See the WDO report.

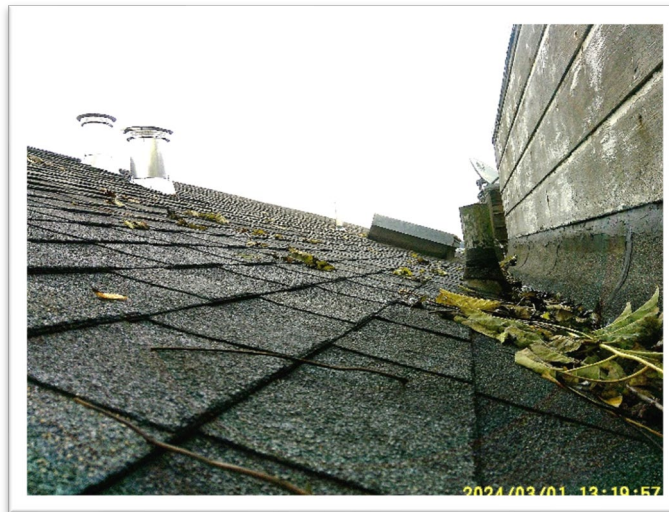
- 29 **Slope:** Pitched.
- 30 **Access:** View over rear roof edge.
- 31 **Cover material:** Standard composition shingles.
- 32 **Condition:** Satisfactory.
- 33 **Maintenance:** Debris needs to be removed from drainage sections.
- 34 **Metal flashings:** Satisfactory.
- 35 **Exhaust/vents:** No corrosion noted.

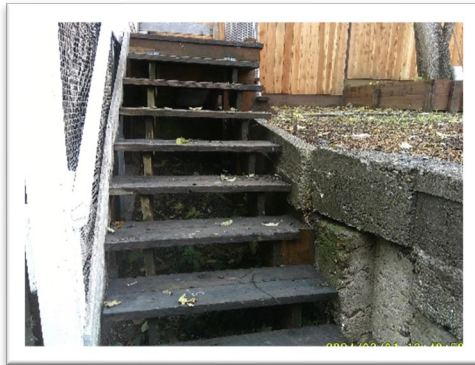
54 **Material:** Wood plank on pressure treated frame. No Guard rail.

55 **General condition:** Dryrot repair required and rail-upgrade to meet safety standards, See the WDO report.

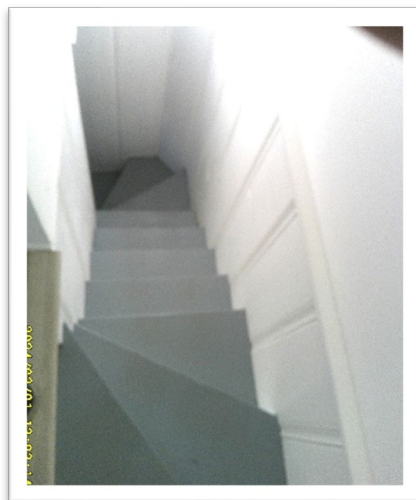
***55.5 Interior stairs lack a hand grip.***
